Track Expert Review of

LA Metro

Exposition Line Two Track At-Grade Junction

Final Report

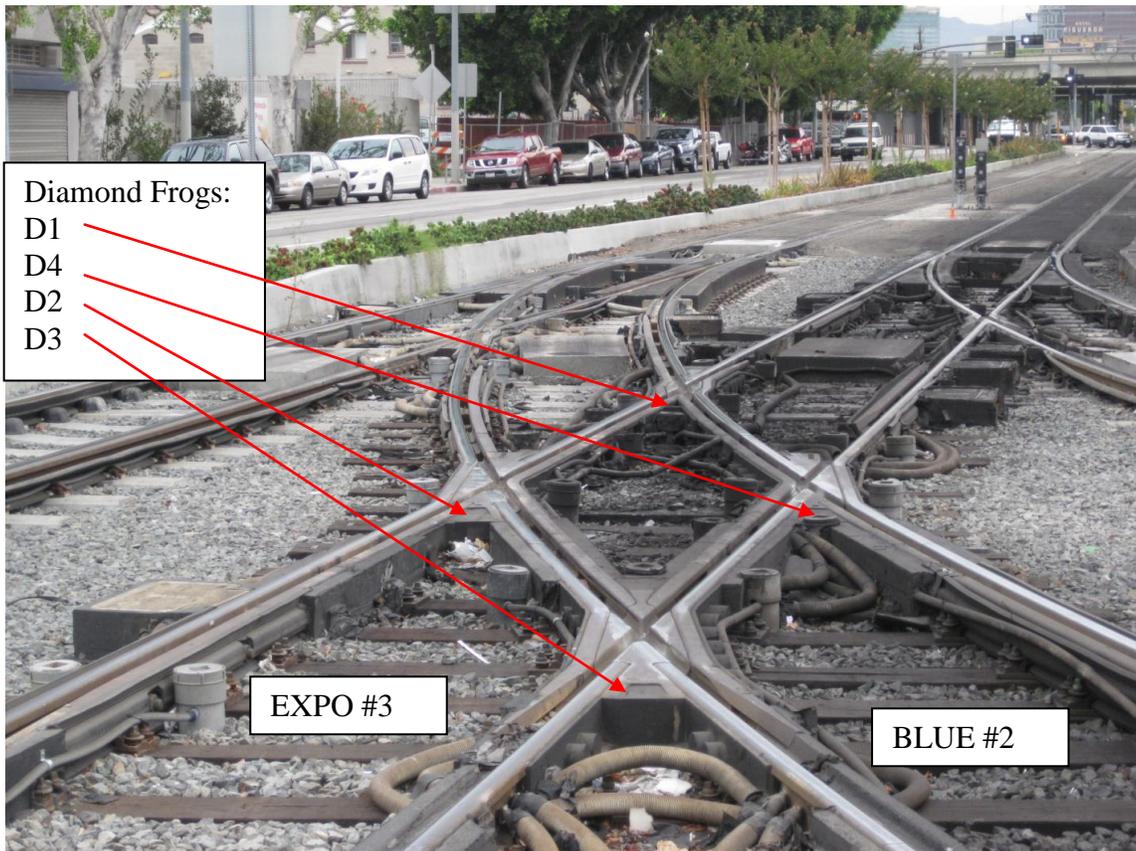
Note: RED arrows indicate direction of normal travel.

Figure 1: Junction with all four Diamond Frogs (D1-D4)

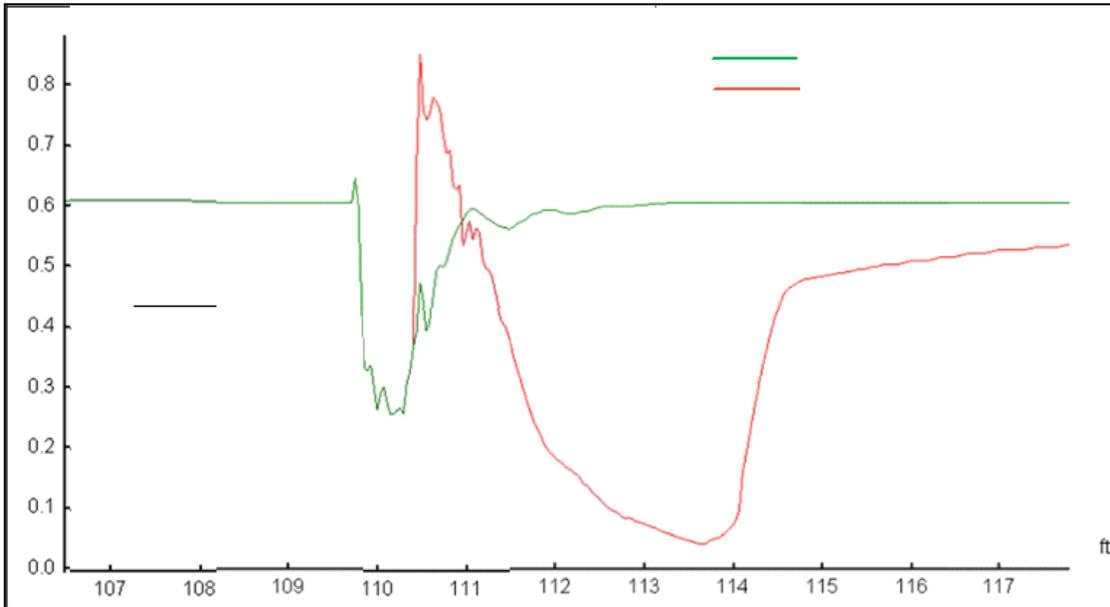
Figure 3. Comparison of L/V Ratio on the Lead Right Wheel through a Standard Frog (Green) and Expo Frog (Red)

As can be seen from this Figure 3, the Expo frog movement showed an L/V ratio of 0.8, as opposed to the standard movement of 0.6. While 0.8 is sometimes regarded as the “minimum” L/V threshold, ZETA-TECH performed a more detailed analysis of the L/V ratio threshold as a function of the actual wheel flange angle and coefficients of friction using the Nadal wheel climb analysis methodology. The results of the analysis showed that for the new wheel flange angle of 75 degrees (the same as was used by ENSCO in the modeling run) and for a range of coefficient of friction of 0.3 to 0.5, the actual L/V derailment threshold is 1.13, well above the model calculated L/V ratio through the Expo frog (of 0.8). This indicates that there is no risk of wheel climb, since the L/V ratio was less than the Nadal calculated derailment threshold.

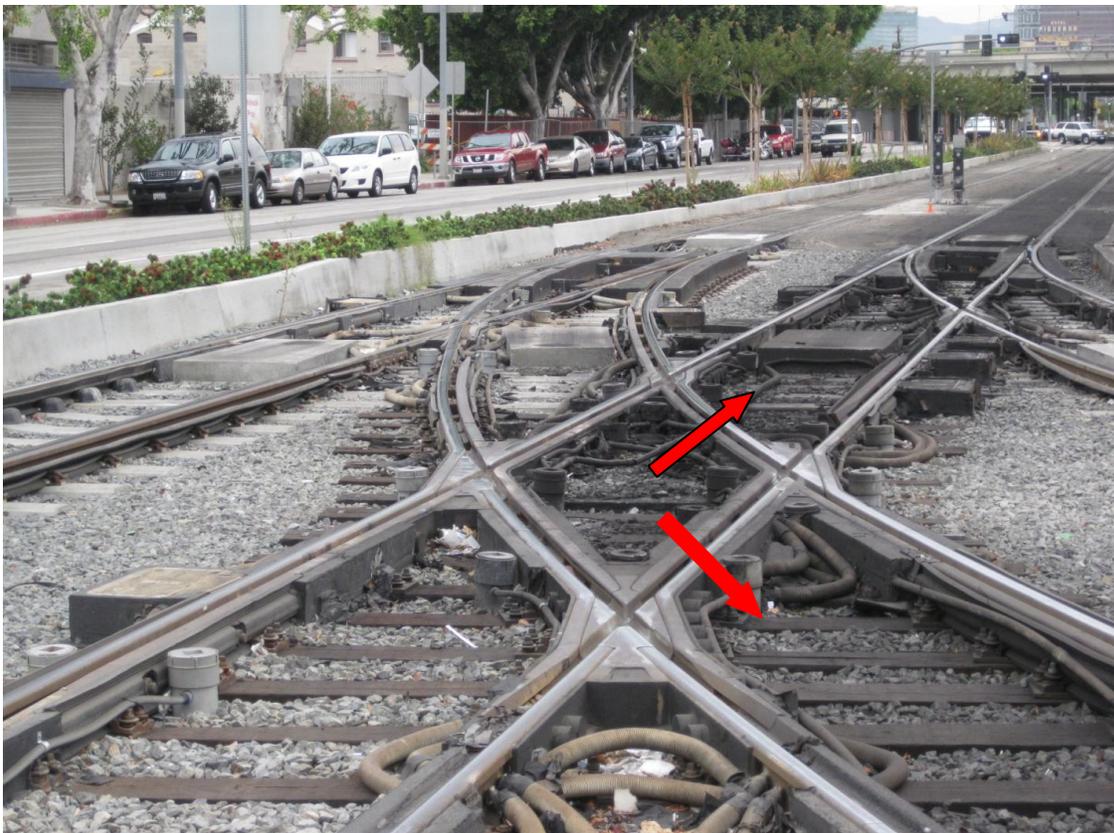
Upon arrival at the Junction Diamond, several trains were observed travelling through the diamond on Track Blue #2 (small radius direction) as well as EXPO #3 (large radius direction). See Figure 4.

Figure 4: Junction Diamond. RED arrows indicate direction of normal travel.

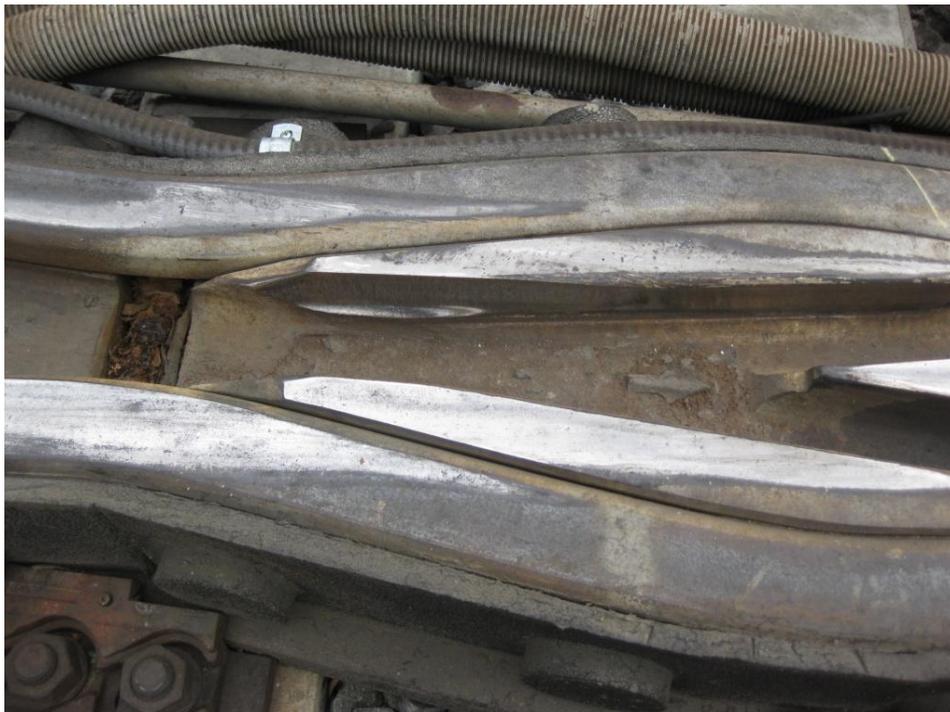
Observation of the frogs elements of the diamond indicates that the flangeways in the diamond on track Blue#2 (both outer and inner rails) are being abraded by the back of flange of passing wheels. In addition, the wing rail of the frog in the turnout on EXPO #3 is being worn by the back of flange of passing wheels. (see Figure 7)

Figure 7: Observed Wing Rail Wear

It would be better if the frog diverging route was reset to standard gauge so that there would be no transition and the frog wing rail would not be subjected to the observed high wear (as noted in Figure 7). However, if, due to time and cost restraints, this procedure is not a realistic option, this lack of transition does not represent a serious problem so long as the "line" rail remains uniform throughout this transition zone. The change in gauge must be facilitated by moving the "grade" rail (inside rail) closer to the line rail by ½ inch and NOT moving the "line" rail from its current position. This transition should take place over a distance not less than the longest axle to axle spacing of any vehicle using this route. In this case, 82.7 inches.

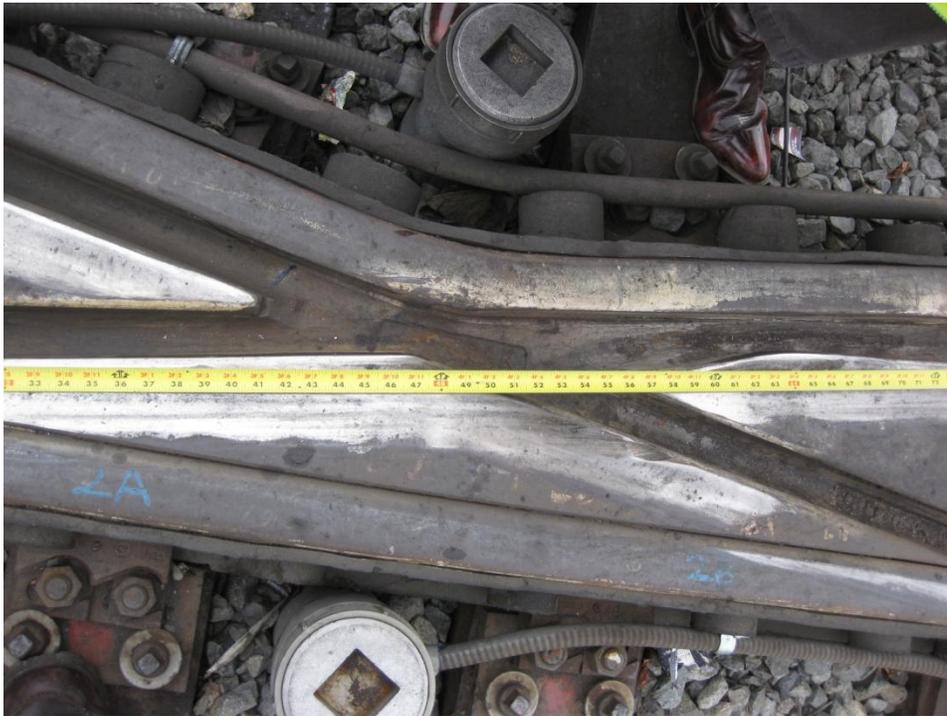
As noted previously, there is a transition ramp welded onto the center frog of the diamond just ahead of the “Blip” that aids in moving the wheel flange onto the Blip without causing a large impact (see Figures 8 and 9). However, this is for Southbound movement of trains, there is no ramp for trains operating in the reverse (northbound) direction.

Also, as can be seen in Figure 8, there is a small section of the flangeway opposite the “Blip” that has been either ground off or worn away that allows the wheel flange to move over when making contact with the “Blip”. Observation of train movements through the junction showed very little impact noise generated at the blip when trains are operating at speeds less than 10 mph.

Figure 8: “Blip” and Ramp on D2

3. It is expected that the welded “Blip” on frog D2 will wear over time, allowing the frog point on D4 to be impacted. Weekly inspections shall be made of the weld and D4 frog to ensure the safe operation of trains through the diamond. Any indication of D4 being impacted by passing wheels shall be reason to remove the diamond from service and build up the “blip” weld back to ½” stand-off.

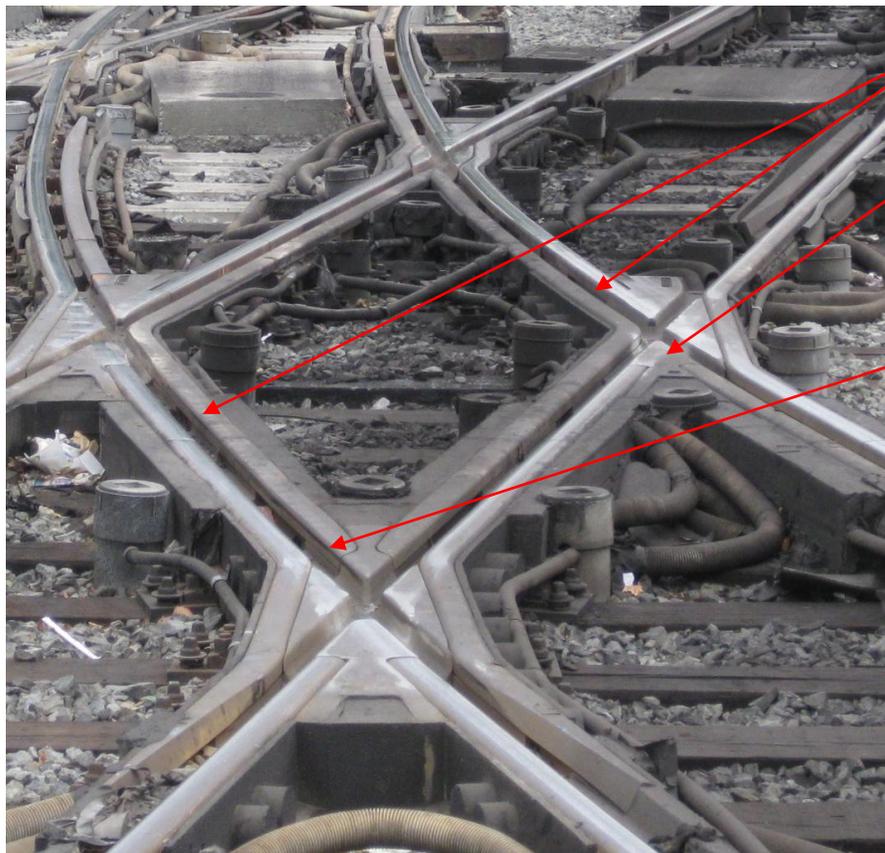
The cause of the initial problem (flange strikes on D4 frog), appears to be the result of wide gauge through the diamond. With the maximum guard face gauge being 53.125 inches and the minimum wheel back-to-back being 53.094 inches, the back of the wheels are contacting both flangeway guard rails simultaneously. As a wheel approaches the D4 frog, it is aimed directly at the ½ inch point (see Figure 10).

NOTE: With wheels pinching both flangeway guard rails, frog D4 must be struck by passing wheel sets. By observation, both flangeway guard rails are being worn by passing back of flanges.

Figure 10: Movement through D4 Frog

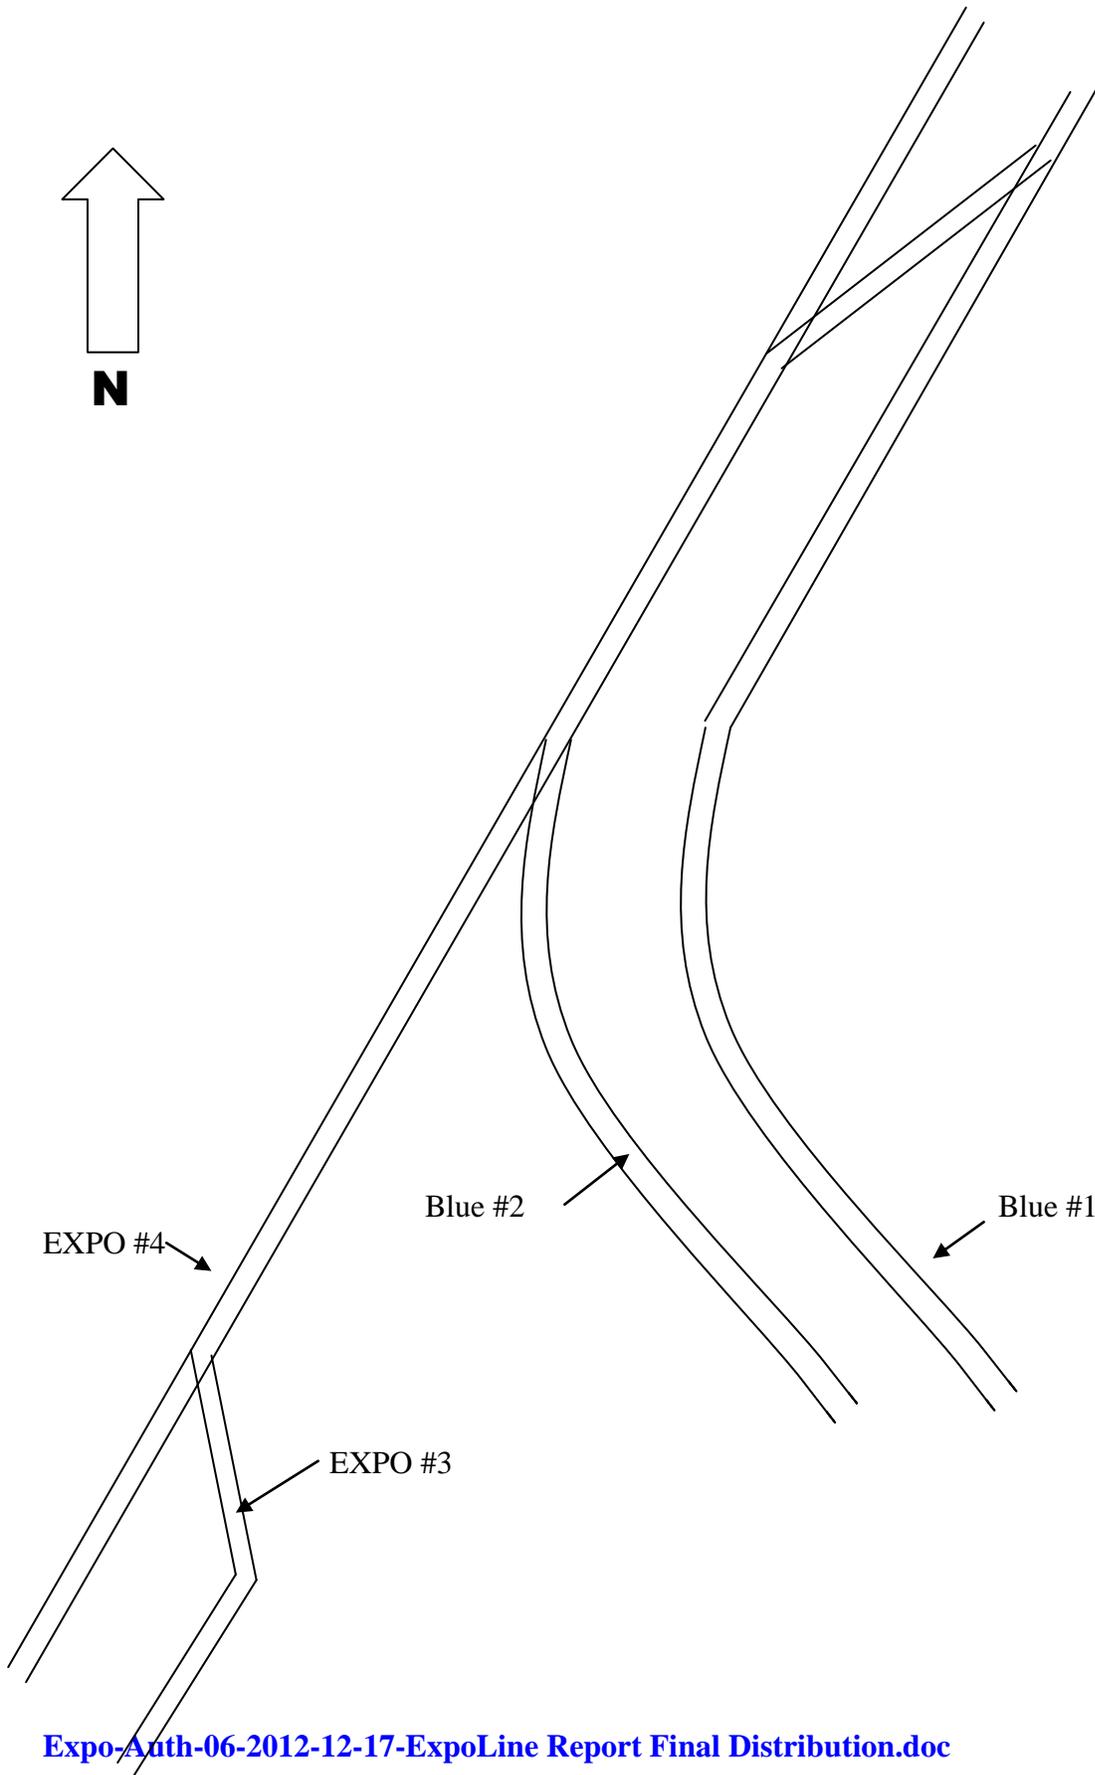
Figure 12A: Replacement Junction Configuration

If this level of operation is acceptable, then it is strongly recommended that the diamond be eliminated and replaced with this new, higher speed, operating configuration. In addition to the higher operating speeds, this configuration would greatly reduce the level of maintenance at this junction. However; it is possible that this layout may impact and limit future operating flexibility and headways and therefore must be reviewed and approved by Operations prior to any modifications being made.

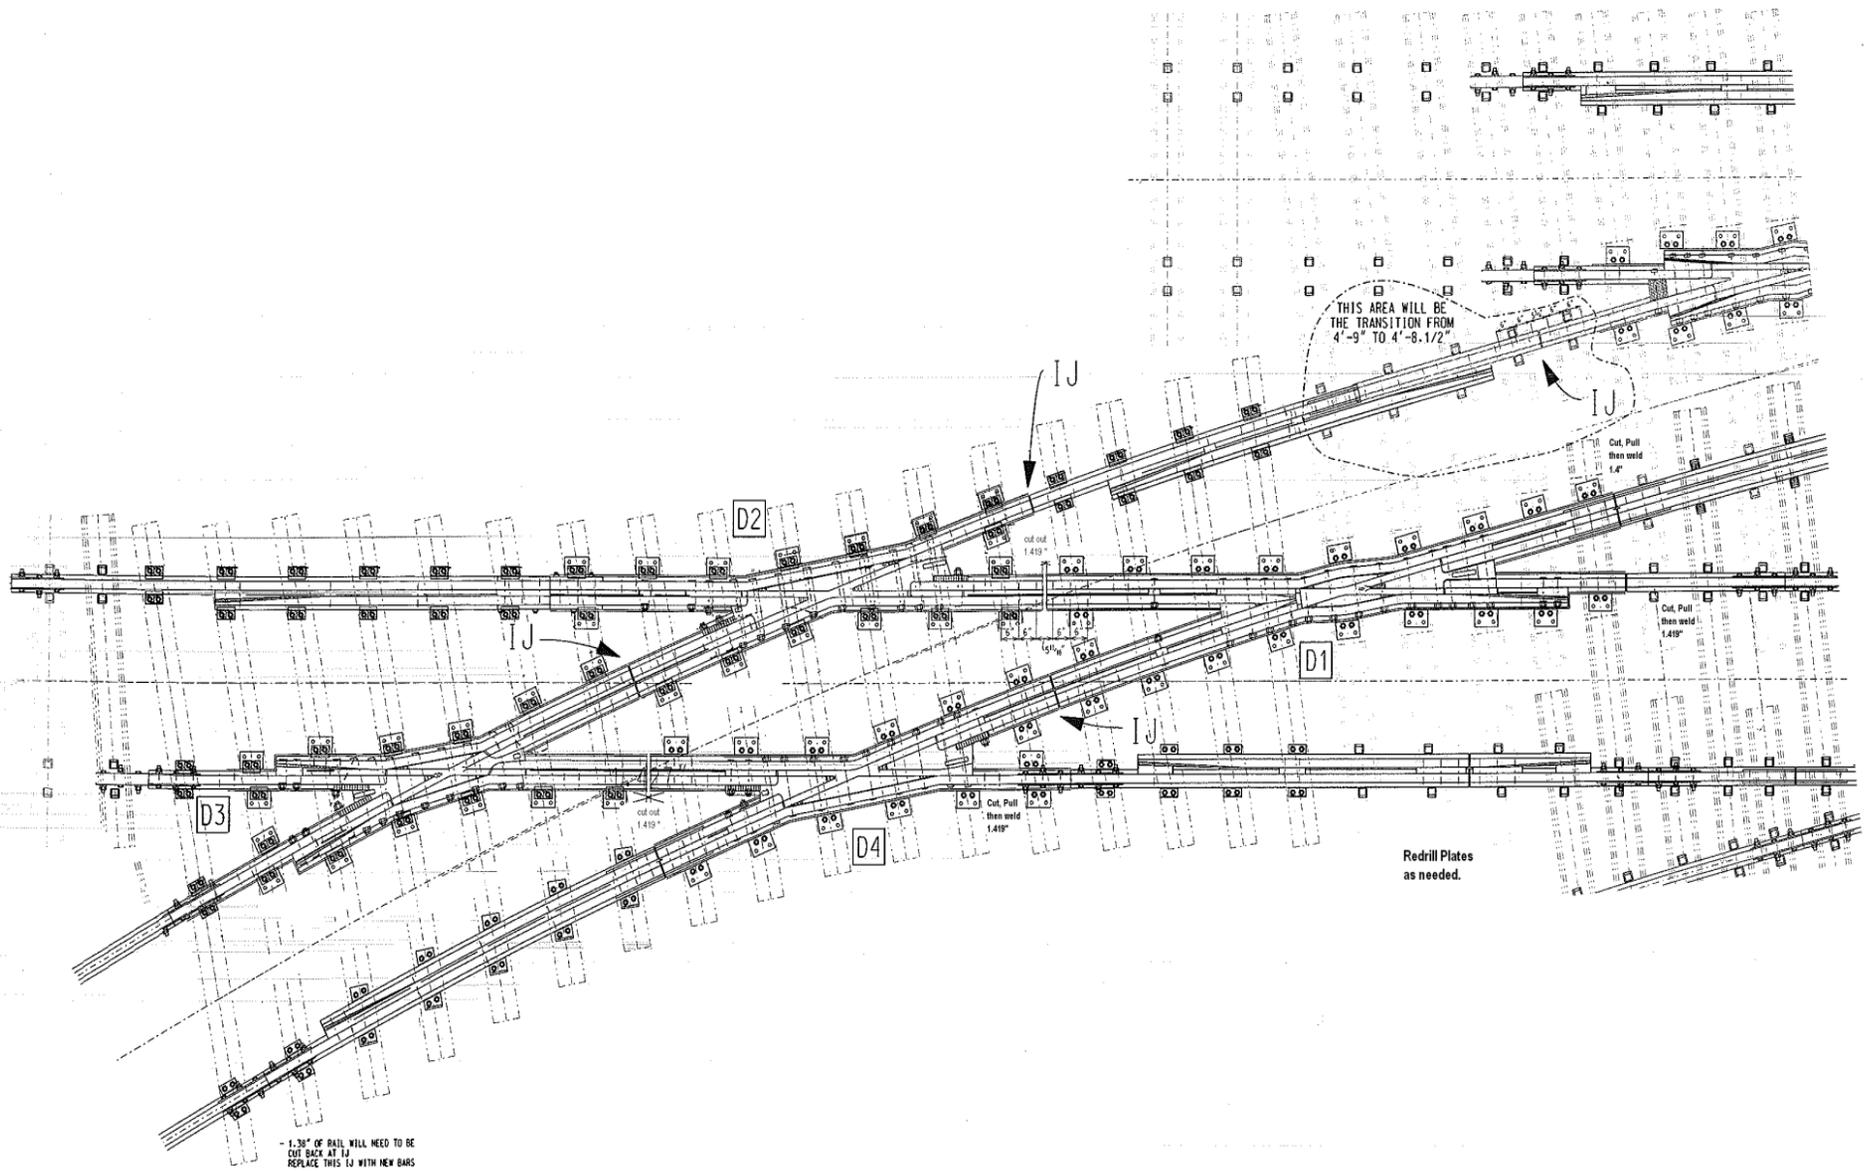
As noted previously, the problem with the existing diamond is the fact that the gauge through the diamond on track Blu#2 has been widened to 57” resulting in the back of flanges of passing wheel sets being pinched between the flangeway guardrails. To mitigate this problem, the gauge must be returned to 56 ½ inches. This can be done by either:

Figure 13: Correction of Gauge

1. Cut the running rail and guard rail in the center of the diamond between frogs D1 and D2, removing a section of rail equal to 1.419 inches.
2. Perform the same rail removal between frogs D4 and D3.
3. North of the diamond, cut both running rails on track EXPO#3.
4. North of the diamond cut the north rail of Blue#2.
5. Also, south of the diamond, cut the north rail of Blue#2 and remove 1.38 inches of rail.
6. Loosen all fasteners between all rail cuts and pull the north rail of track Blue#2 together at the cuts noted in steps 1 and 2.
7. Weld or bolt up all remaining rail cuts and reset all plates and fasteners as needed.
8. Replace insert at D2, removing both ramp and “blip”.

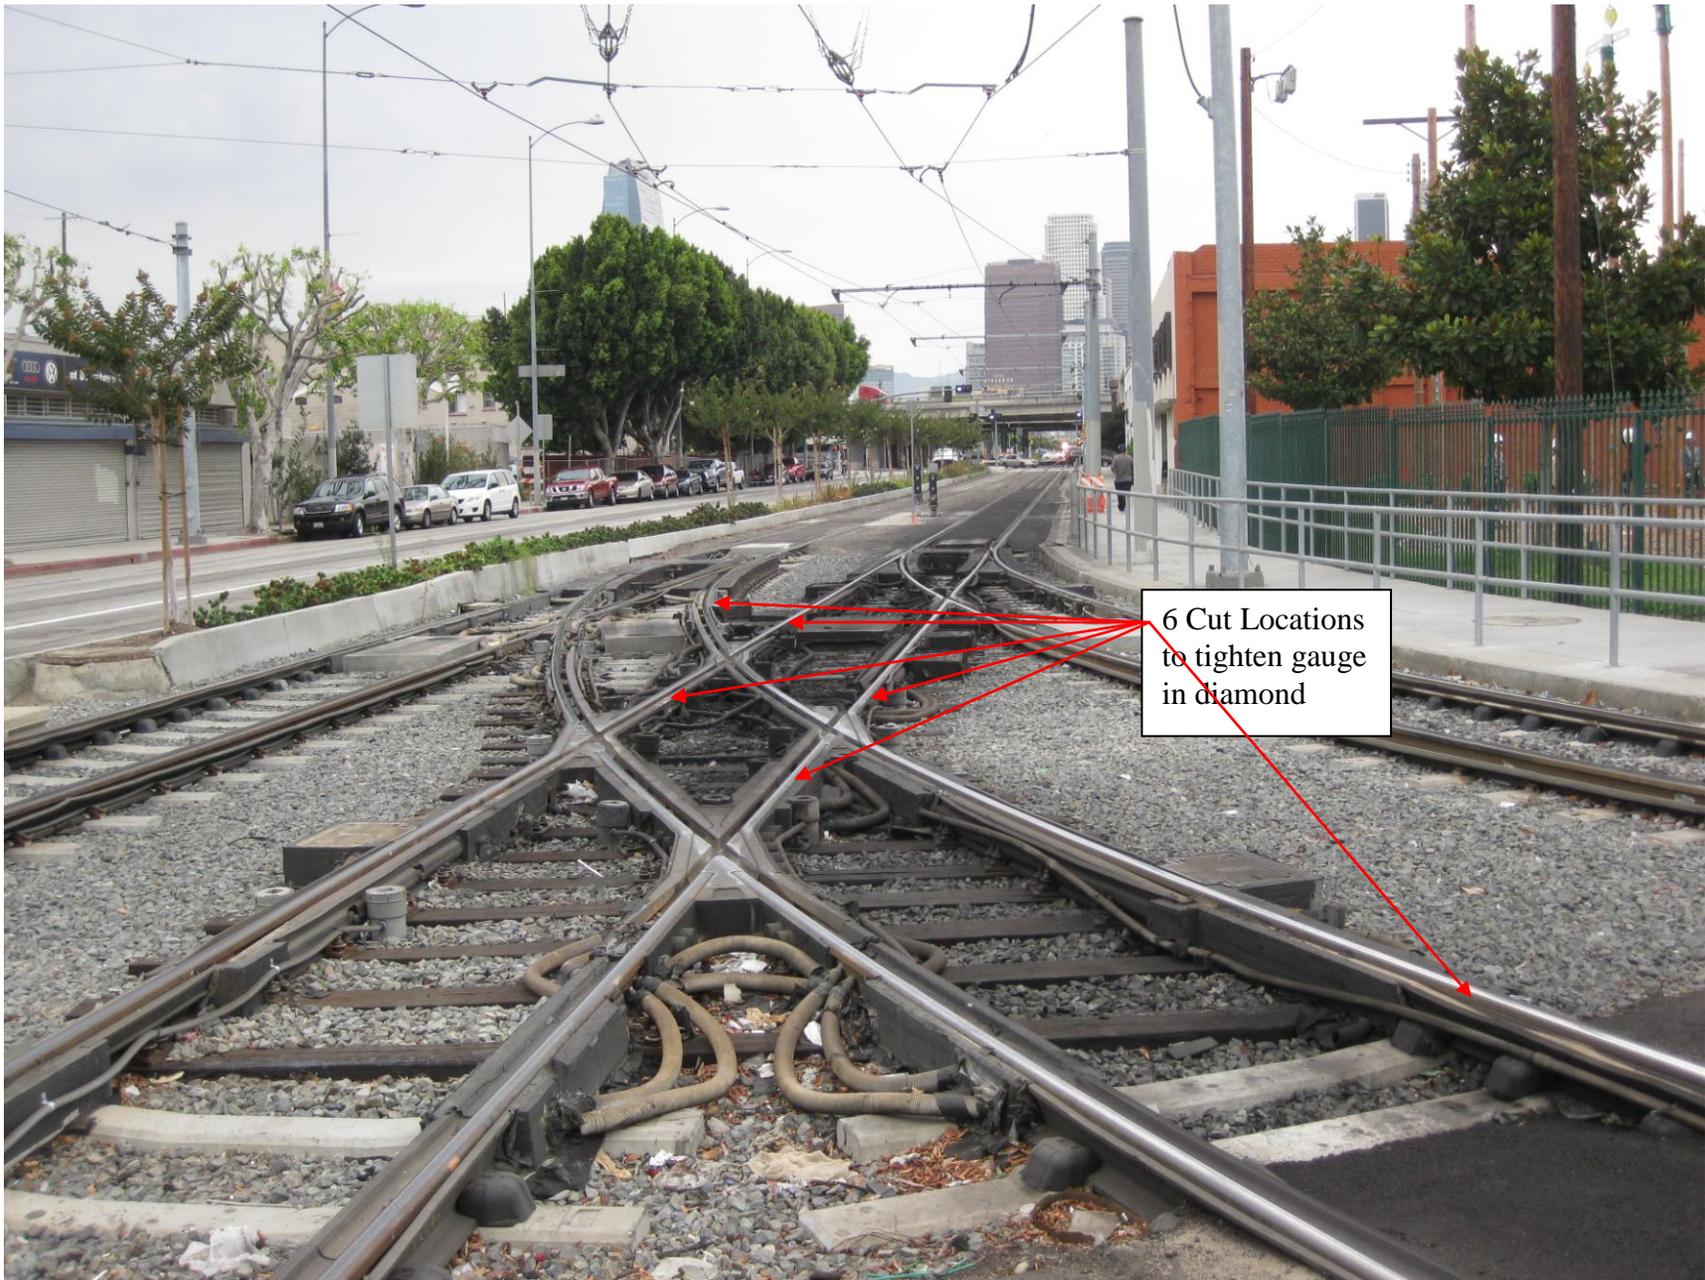
Figure 14: Locations for Cutting Rail to Restore Gauge
