Track Expert Review of

LA Metro

Exposition Line Two Track At-Grade Junction

Final Report

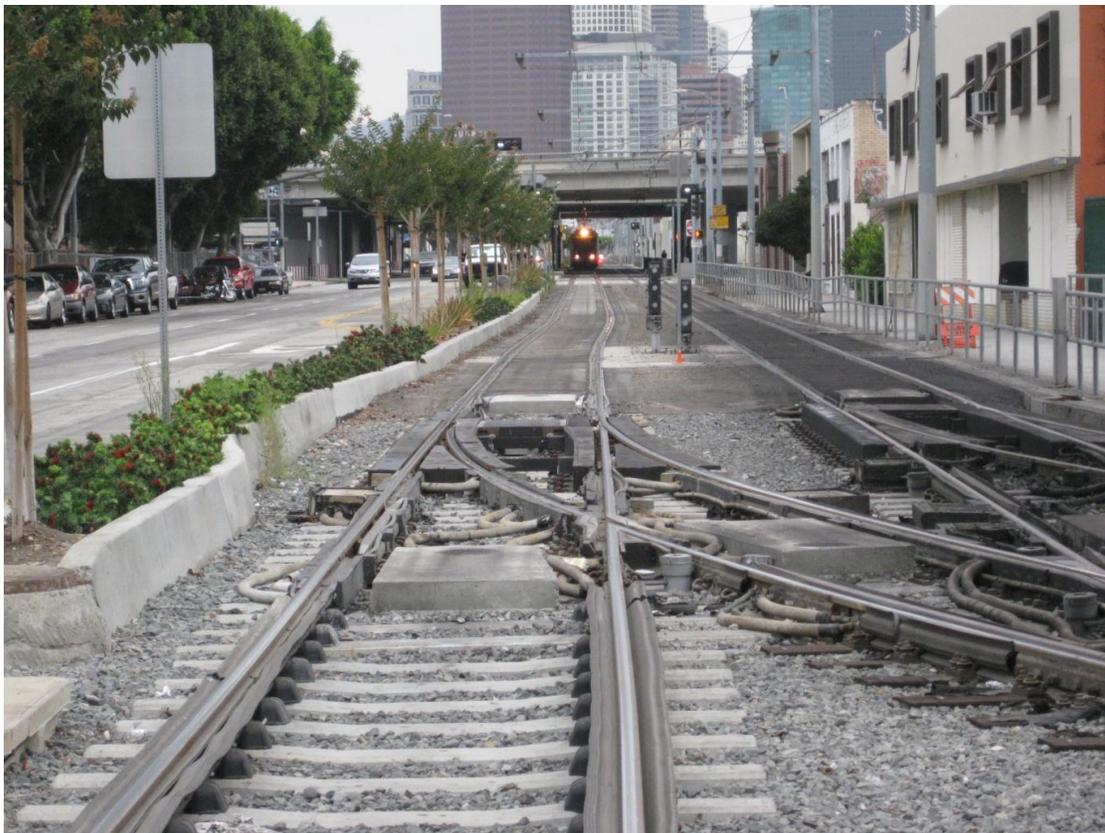
Figure 5: Straight move view of the Junction Diamond Looking North

The diamond junction is built on wood tie and ballast track where-as all other track and turnouts are built on concrete ties or embedded track (Figures 5 and 6).

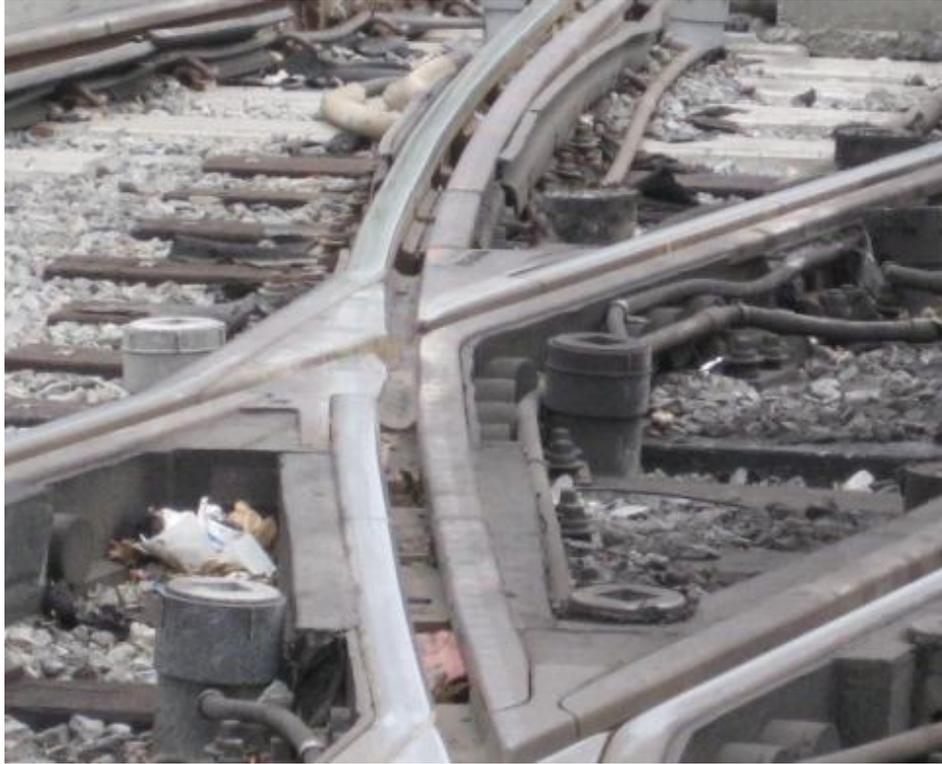
Figure 9:

As noted previously, there is a transition ramp welded onto the center frog of the diamond just ahead of the “Blip” that aids in moving the wheel flange onto the Blip without causing a large impact (see Figures 8 and 9). However, this is for Southbound movement of trains, there is no ramp for trains operating in the reverse (northbound) direction.

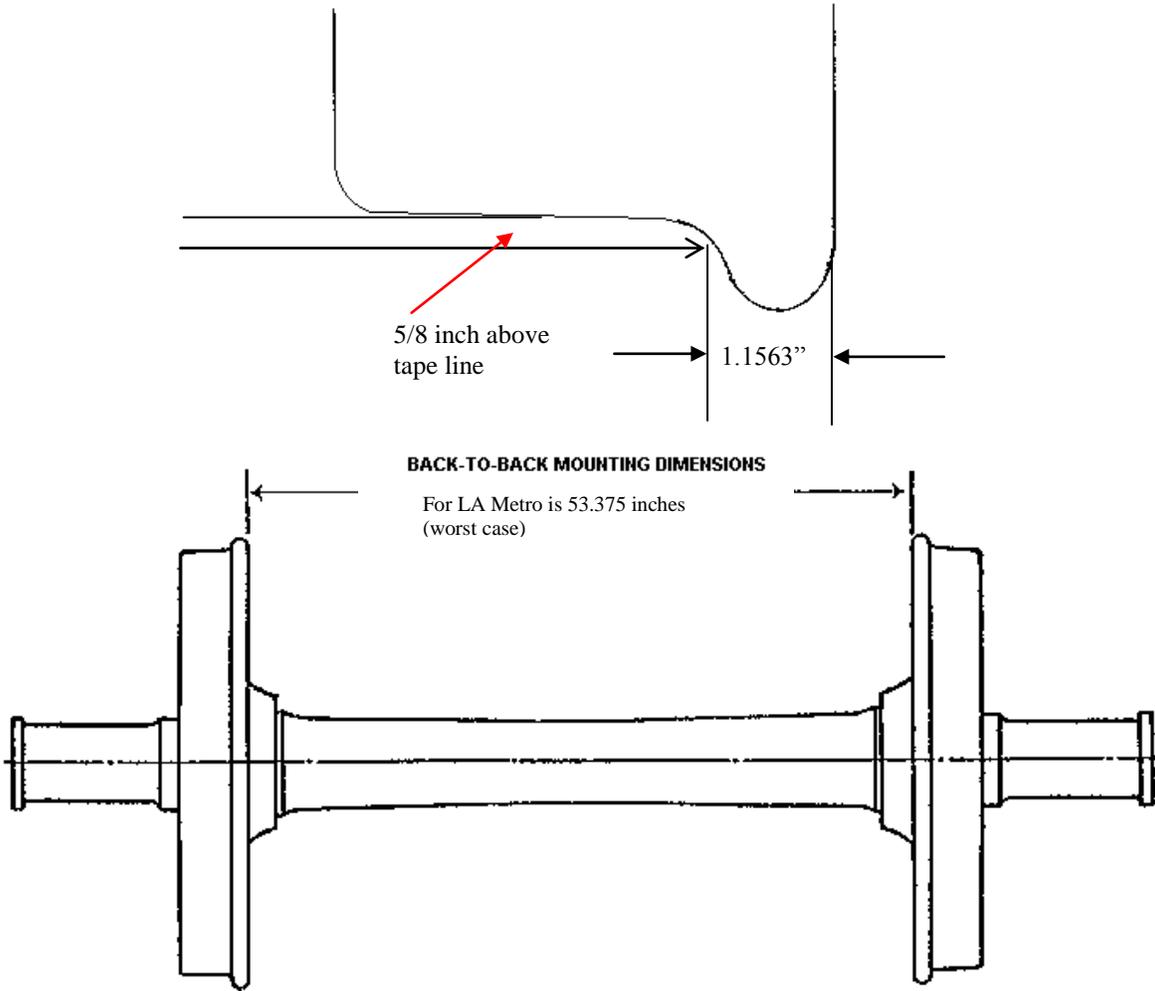
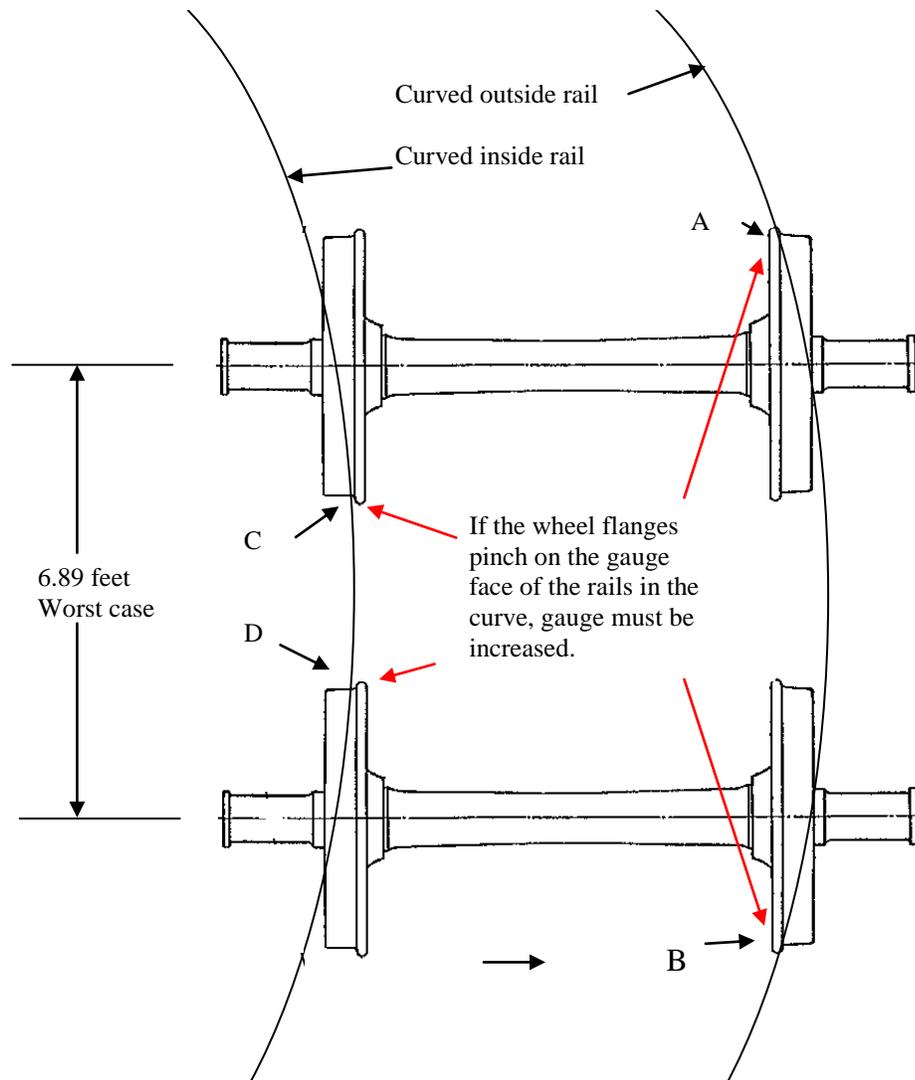
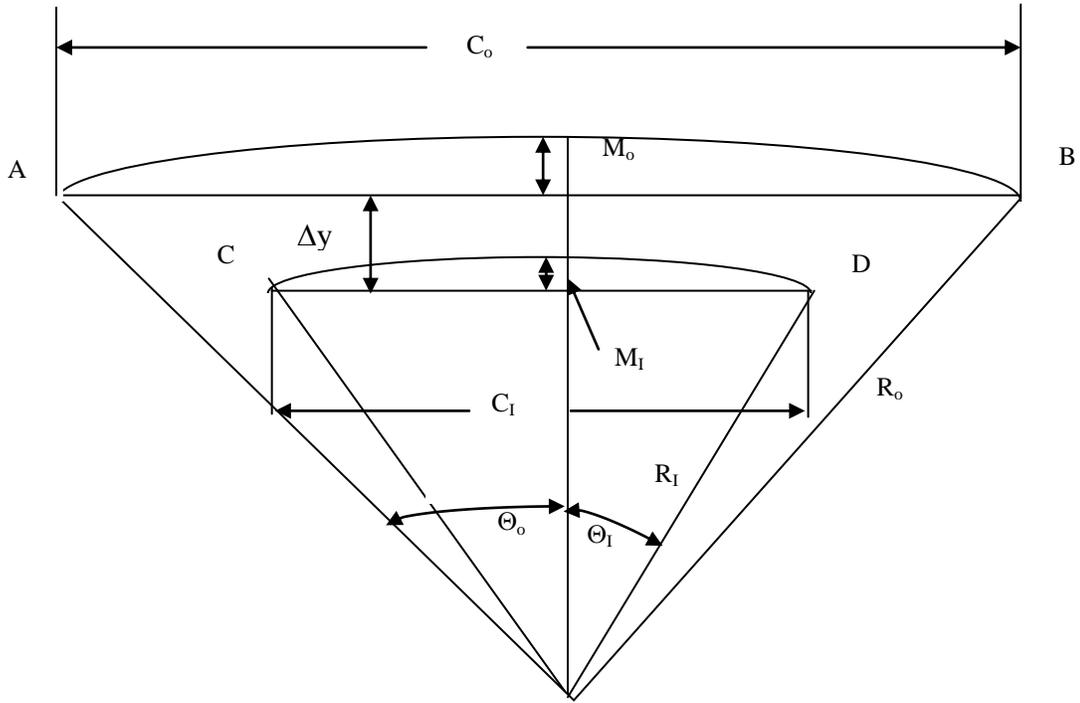
Figures 11A through D show the key measurement and analysis parameters.

Figure 11A: Wheel Dimensions. Note actual contact is at the $\frac{3}{4}$ " point.

Figure 11B: Wheel back to Back Dimensions

Figure 11C: Truck Negotiation of Curve

Figure 11D: Clearance Calculations
